To our workshops

Field Action 10-107

Level 3 customer notification

Think has decided to implement a Field action on the AC mains inlet assembly. The reason for this field action is to secure against water ingress into the electrical circuit board inside the BMI.

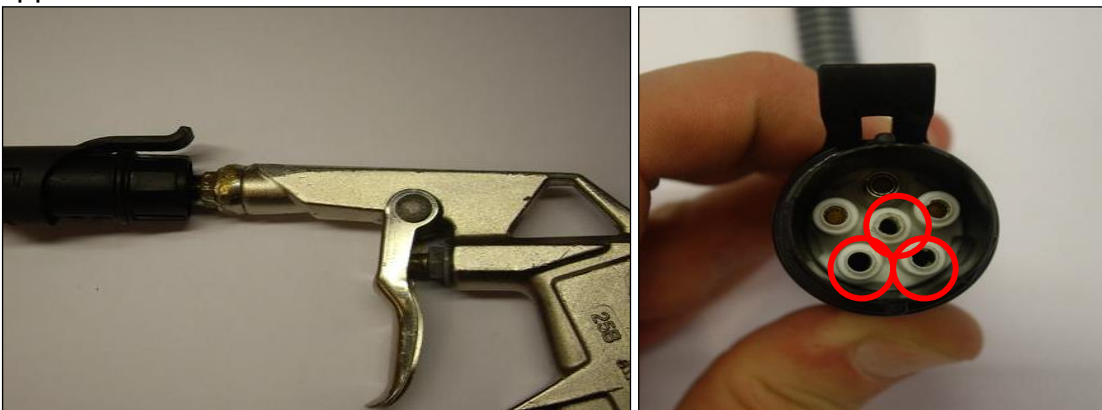
If there is trace of water in the tube or connector, there has potentially been water ingress in the BMI. The BMI must be replaced. If there is no trace of water, perform an isolation test using Zebra Monitor

Using dry compressed air and a nozzle gun, dry out possible humidity in the connector by pressing the nozzle gun into each unpopulated terminal position and releasing air for approx. 20 seconds.
